# **CAPP**

International Research Project on the Effects of Chemical  
Ageing of Polymers on Performance Properties

## **DEGRADATION OF COFLON IN METHANOL AT TEMPERATURES AROUND 140°C**

**Document no:** CAPP/M.6

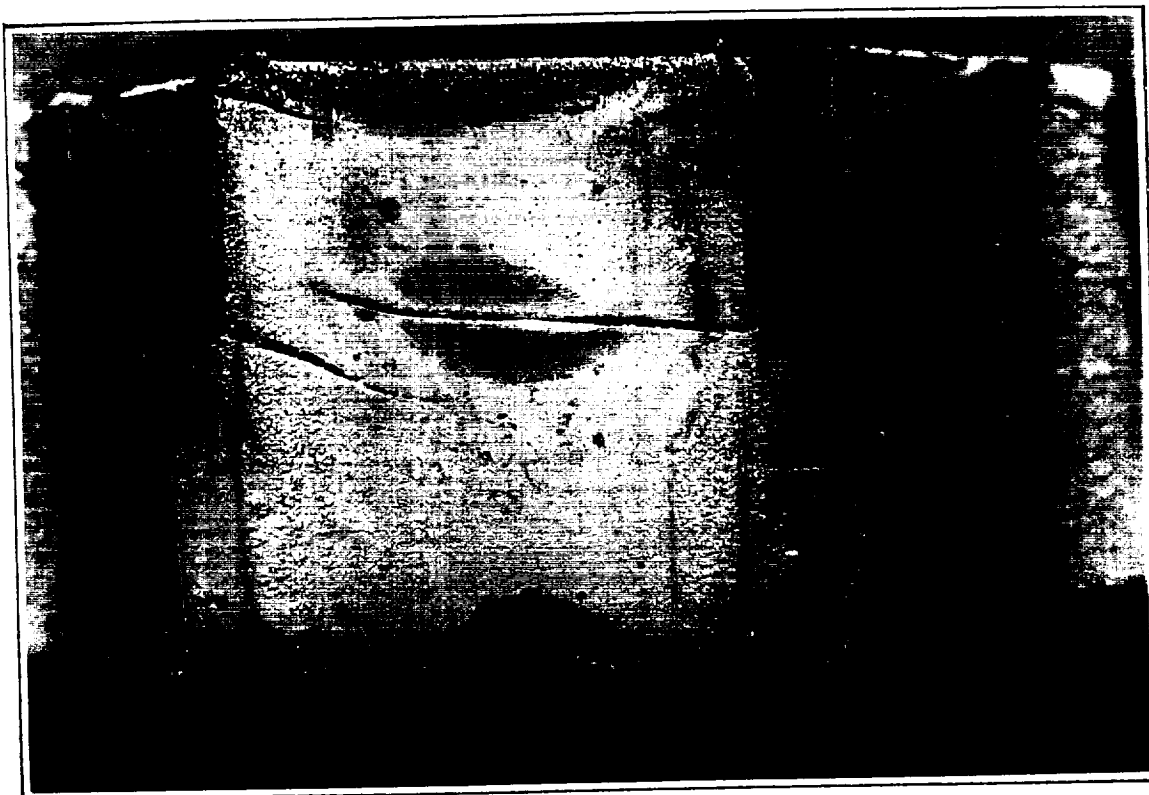
Fig. 3(b) Fractures in 4-point bend strained sample after exposure to hot methanol at vapour pressure for 14 days (x3)

After the test finish and cell dismantling, inspection of the samples showed that those in the bending rig had fractured significantly at the bending points (Figure 3(b)). Other cracks, some orthogonal to the main fractures, had also been formed. The observation of some strands at the surface (Figure 3(c)) agreed with the suggestion that dissolving had commenced, albeit more slowly than in the initial test. The unstrained samples, although intact, were in some cases a little bent and also showed numerous fine cracks right through their thicknesses, plus surface discolorations (Figures 3(d) and 3(e)). Strain may not be essential to the phenomenon occurring, but may affect the kinetics.

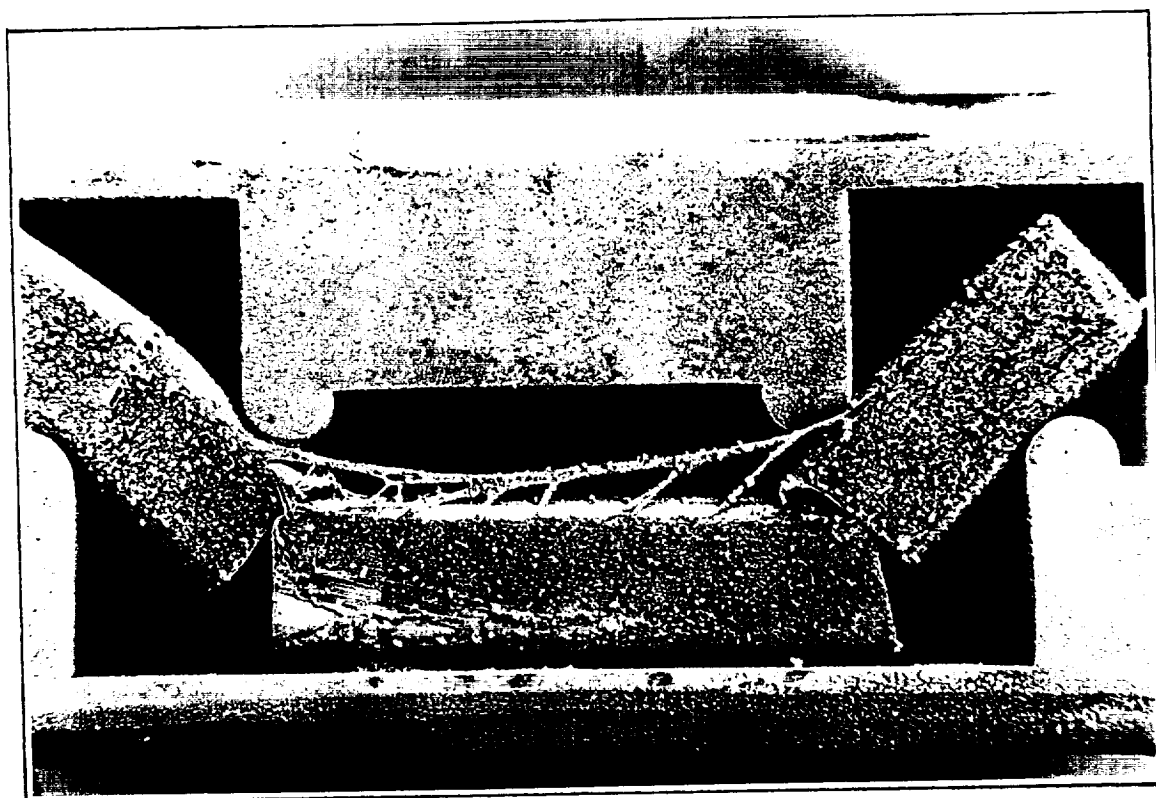
Fig. 3(c) Deposited filaments of PVDF after the exposure above

FIGURE 3 (cont) Coflon samples during the first test (at 130-140°C) in the glass-ended cell (x3.5)
